# Environmental Screening Report

DEPARTMENT OF PUBLIC HEALTH ENGINEERING

July'18 – November'19

[A report on WASH facilities and its environmental impact under PEDP-4]

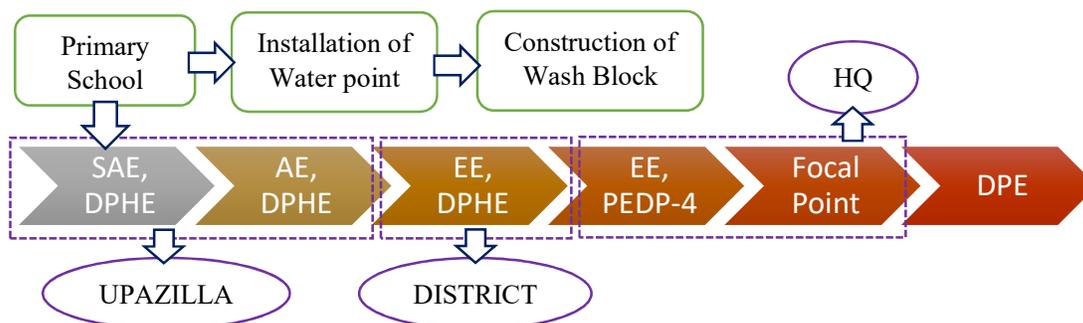
Fig. 1. Method of environmental safeguard screening

Data for environmental safeguard screening during the installation of water sources and maintenance of Wash Blocks have been collected from the schools through DPHE official sources using the structured format (copy enclosed in Appendix-1 of this report). Data collected from grass root level have been entered into ‘Master Environmental Survey Outcome’ Spreadsheet by MIS UNIT and kept structured for database and reporting. A flow diagram of the screening method is depicted in Fig. 1.

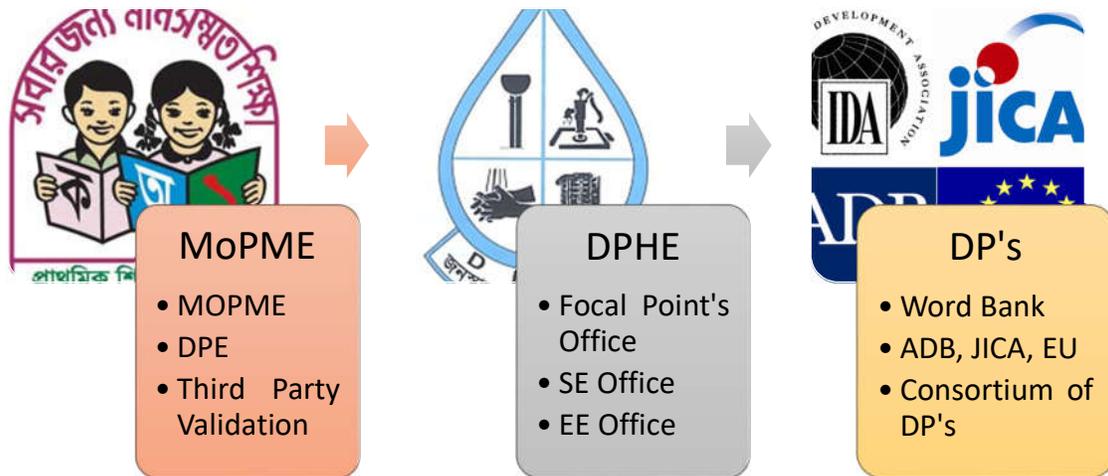
Fig. 2 Monitoring scheme in PEDP-4

The subcomponents of PEDP-4 especially the infrastructural implementation are comprehensively monitored by several parties from commencement to operation. Fig.2 shows the monitoring scheme in PEDP-4 operated by different agencies. Being an implementing agency, DPHE is involved significantly from construction till post-construction monitoring. Role of DPHE is depicted in Fig.3. It can be noted that the defect liability period for installed water points and constructed wash blocks are 02 and 01 year respectively. This implies that contractor is responsible to rectify any sort of defects within this time frame counting from the date of handover of tube well and wash block. In order get a clear picture of ongoing and completed works, DPHE district office arranges monthly monitoring meeting with all concerned officers and staffs of that district. Executive Engineers thus address the issues of monitoring to the assistant/ sub assistant engineers monthly. Officers of concerned district used to visit the site frequently in order to monitor the ongoing and completed works and also focus on the environmental safeguard aspect. Visit from Focal Point’s Office and DPHE Head quarter happens frequently.

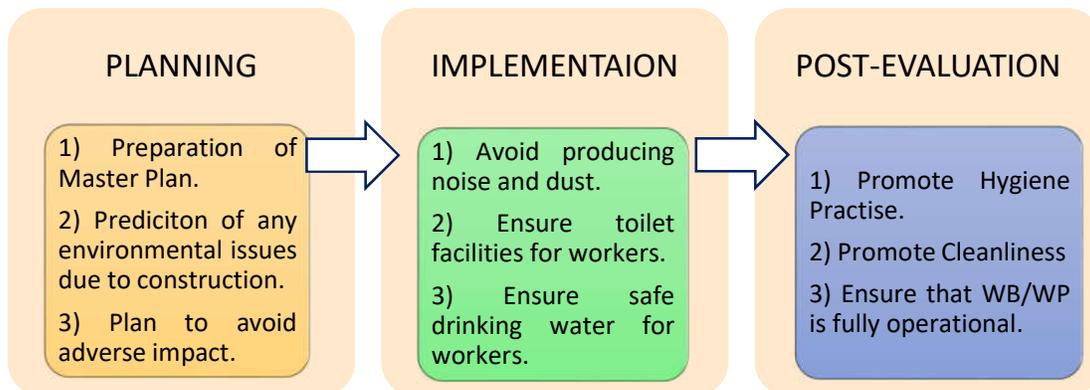
Fig. 3 Role of DPHE in environmental monitoring

DPHE district office arranges coordination meeting between DPHE (EE, AE, and SAE) and DPE officials (DPEO, UEO) in every 3 months. A glimpse of the co-ordination meeting is depicted in Fig. 4. In this meeting, officers from department of primary education point out the necessity of monitoring of particular school which are immediately addressed by DPHE officials. In addition, mechanics of

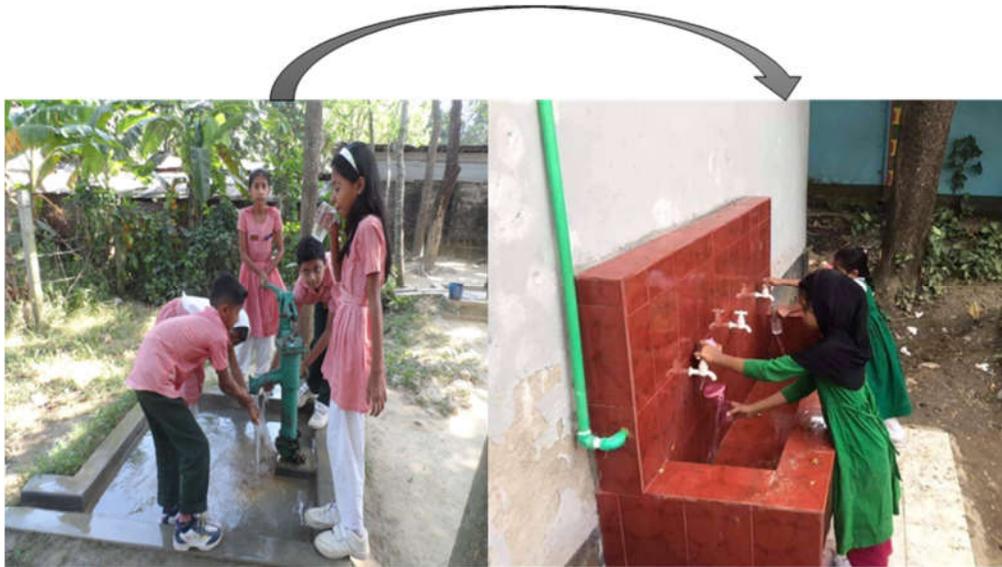
Fig. 5 Improved water sources by TSP from hand tube well

In order to mitigate the concerns and to make the water sources more popular and user friendly, DPHE started installing Tube well with Submersible Pump (TSP) in all the primary schools under PEDP-4. This option has special features such as-

- Running water supply with storage facility.
- Multiple user can access at the same time.
- Promote hygiene practice through safe hand washing.

Fig. 5 shows the previous and improved water supply facilities in primary schools under PEDP-4.

Installation of tube well with submersible pump added values to its user especially young user which eventually increases the easy access to safe drinking water result in health benefit as well as diminishes water logging and drainage problem.

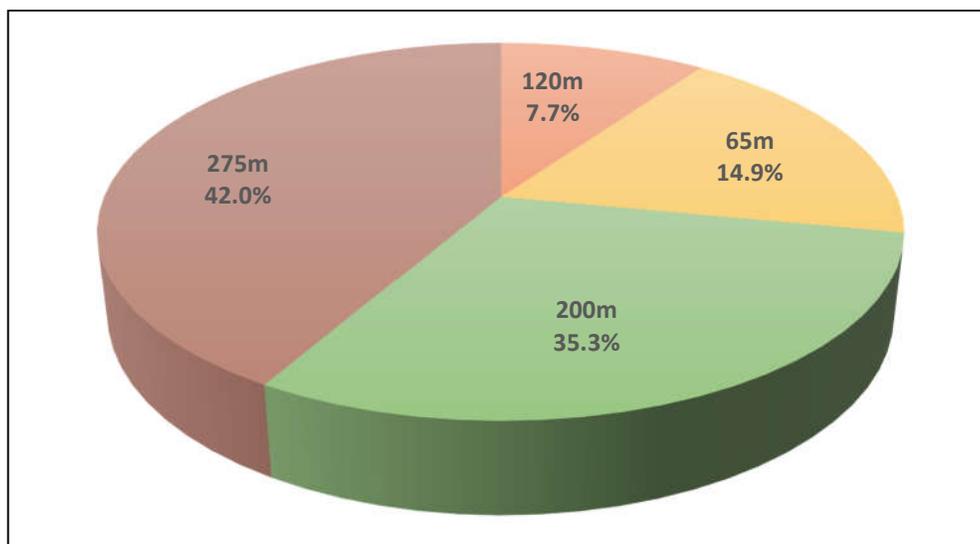
Fig. 6 Distribution of water points based on depth

DPHE installed tube wells of varying depth in different primary schools of Bangladesh considering the geological formation of respective district. Although the depth of tube well is depended on the suitable water layer, all the tube wells installed in the reporting tenure can be broadly categorized into four distinct types based on the depth of tube well. Fig. 6 depicts the classification of tube wells based on depth. It is clear that 75.1% tube wells were installed at a greater depth of more than 200m. Number of shallow tube wells were in the range of 15% where the depth is less or equal to 65m.

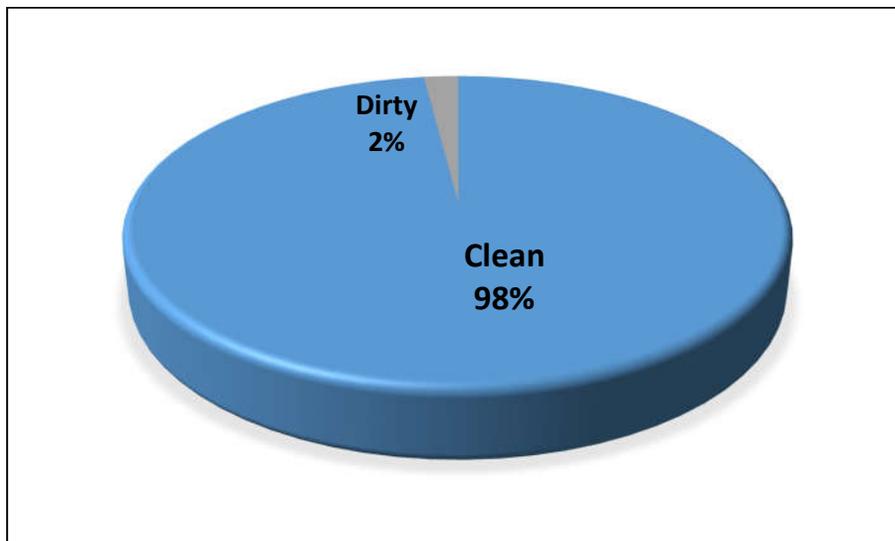
Fig. 7 Environment of water supply facility

In case of water points 'Clean Environment' refers to the surrounding of the installed water option. If the surrounding environment is not dirty and/or not covered with algae then it would be referred to as 'Clean'. Post installation monitoring of all 388 water points have been conducted. Clean environment was found in 380 water points which is 98% of the total water points as depicted in Fig. 7. Causes of dirty environment of water supply facility were blocked drainage due to waste dumping near the outlet. It can be noted that due to the provision of basin type water points, water logging and or other problems related to dirty environment have been dramatically reduced than that observed during the environmental screening of other types of tube well installed in PEDP-3 program.

During the monitoring phase, mitigation measures were suggested to the concerned school such as cleaning of basin, removal of leaves and other utensils that causes blockage of the drains etc. Because of taking mitigation measures, caretakers' training and routine maintenance during monitoring phase, environment of water supply facility improves to 100% from 98%.

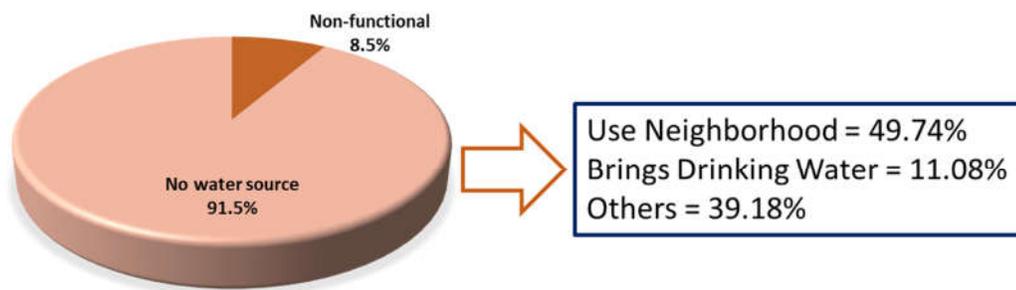
Fig. 8 Status of water points prior to installation

During preliminary survey it was found that (Fig.8), out of 388 schools 91.5% did not have their own water option. 49.74% of them used the facility of their neighborhood. Though 8.5% schools have their own tube wells, yet those tube wells were found as non-functional or did not provide sufficient water during dry season. From the lessons learnt during the environmental screening in PEDP-3, DPHE took initiative in solving the above problem by installing new tube wells with submersible pump but at different depth due to site geology.

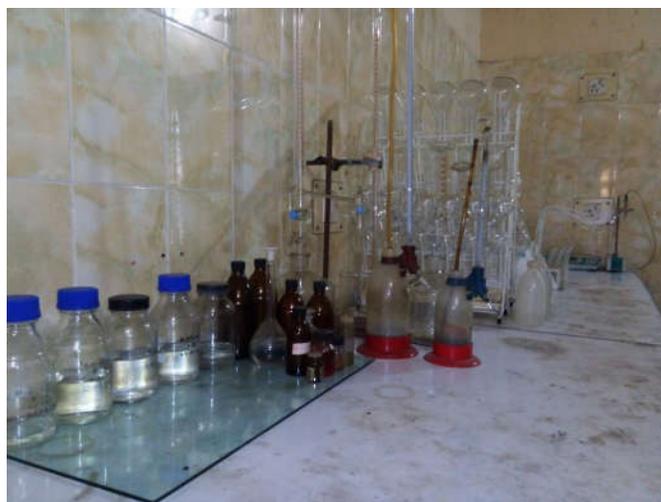
Fig. 9 DPHE Zonal Laboratory setup for water testing

After installation of new water point in the said 388 schools, laboratory tests were conducted to identify potential hazards of Arsenic, Iron and Chloride in water. The tests were done by the laboratory circle of DPHE and the reports are stored in the DPHE MIS database. Figure below shows laboratory testing facilities of DPHE. None of the said 388 water points have any concern about water quality i.e., the arsenic, iron and chloride content were found below 50ppb, 10mg/l and 600mg/l (1000 mg/l in coastal belt) respectively. Ample field tests were conducted in those schools during post monitoring phase by DPHE. The reports were found in the closer range to the reports of DPHE laboratory test. A sample copy of water test report is provided in Appendix-3 of this report.

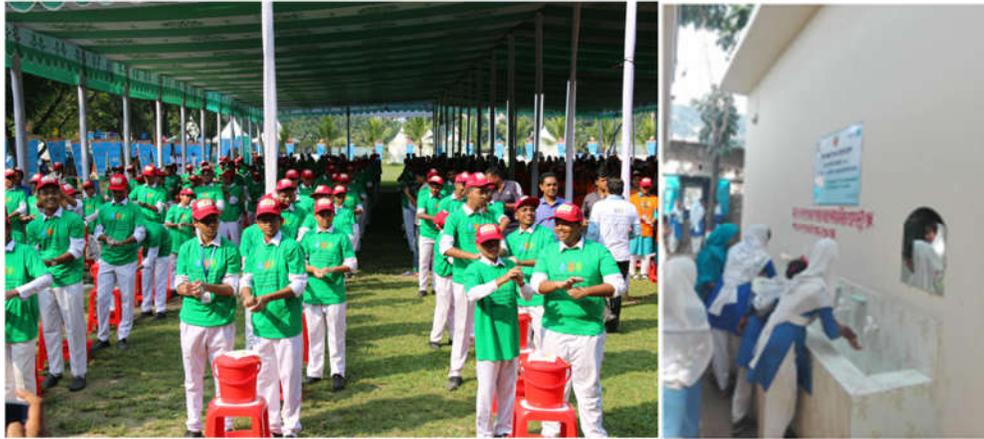
**Fig. 10 Students practicing handwashing**

Working with the moto of ‘clean hand, safe hand’ DPHE confirmed the installation of tube wells with running water supply by provision of submersible pump in all the above mentioned schools during the reporting tenure. Construction of state of the art wash basin for drinking as well as hand washing ensured total hand washing facilities in the school. A glimpse of the hand washing performance is depicted in Fig. 10.

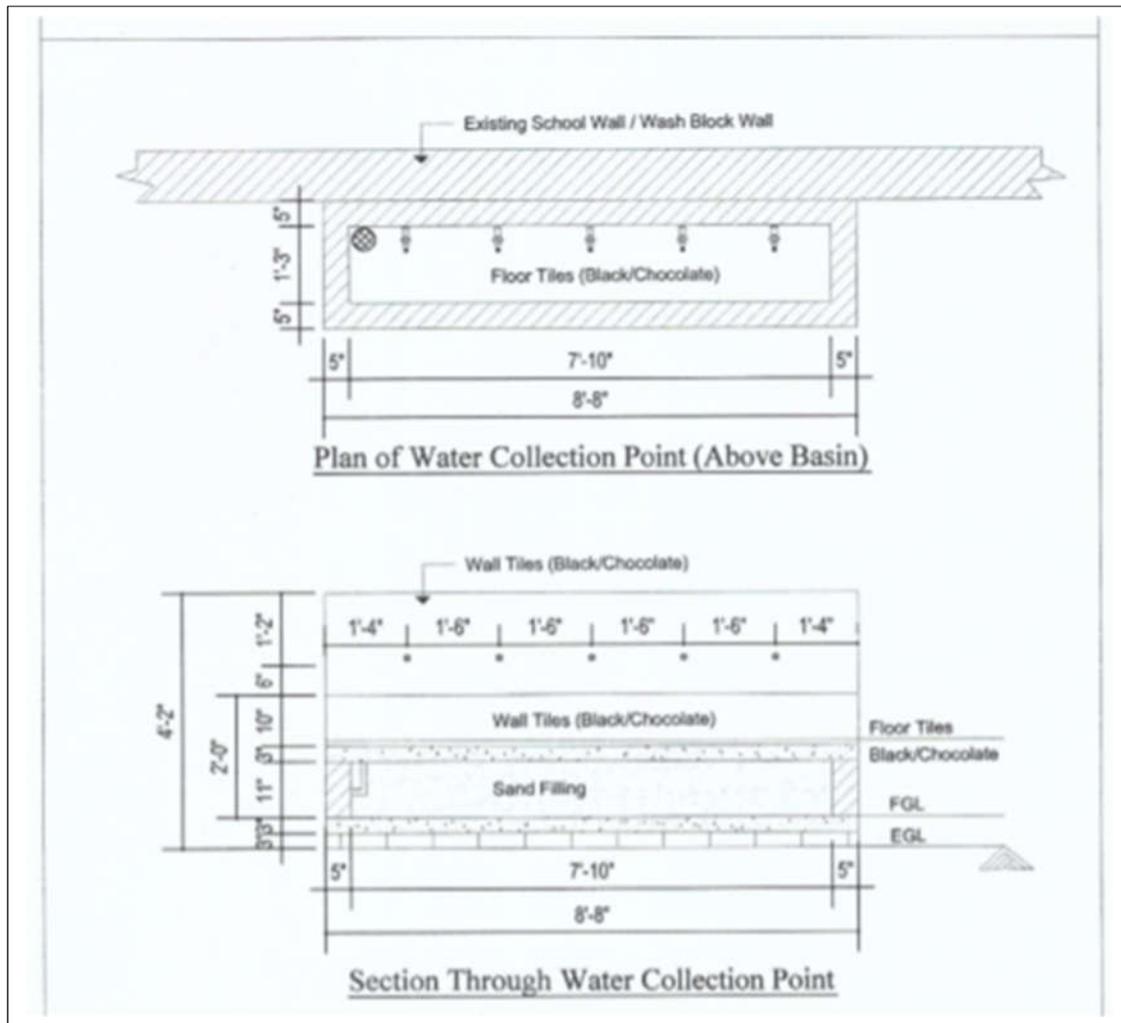
## Appendix-2: Drawing of water collection basin

- 1) Pipe out used water to the existing drains.
- 2) Construction of 5 user water collection basin having 50mm dia. PVC washout pipe. (Drawing attached in Appendix-2).
