Fourth Primary Education Development Program (PEDP-4)

Semi-Annual Environmental Monitoring Report

DEPARTMENT OF PUBLIC HEALTH ENGINEERING

July 2022 – Dec 2022

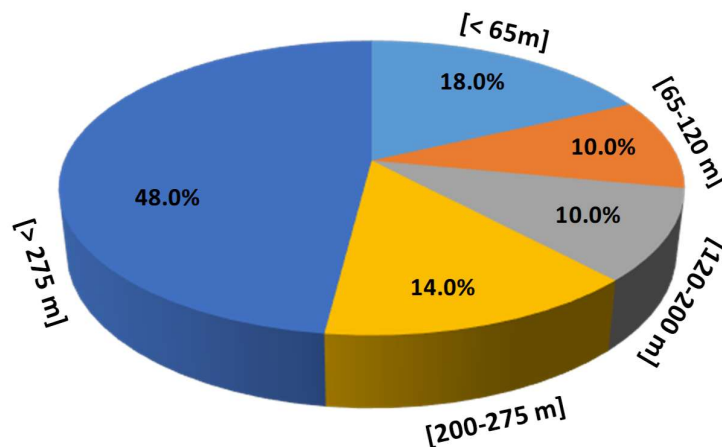
Fig. 6 Distribution of Water Points based on Depth of Boring

DPHE installed tube wells of varying depth in different primary schools of Bangladesh considering the geological formation of respective district. Although the depth of tube well depends on the suitable water layer, all the tube wells installed in the reporting tenure can be broadly categorized into five distinct types based on the depth of tube well. Fig. 6 depicts the classification of tube wells based on depth. As shown in Table 2, a total of 1,668 nos. of water points were installed under PEDP4 during the reporting tenure. It is clear from Fig. 6 that 48% tube wells were installed at a greater depth of 275m or more which is considered as deep tube well. Around 18% tube wells were installed in shallow depth (<65m). Tube wells installed in between 65m to 275m are also deep tube wells and this percentage is second highest (34%) amongst all the installed water points.

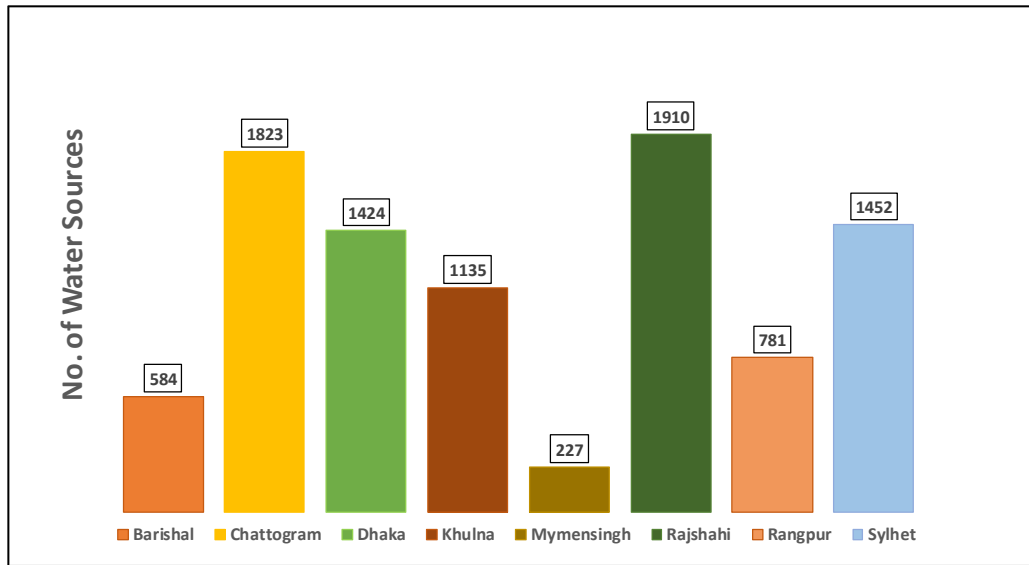
Fig. 7 Countrywide distribution of water points

Countrywide distribution of tube wells and wash blocks were analyzed and division wise categorization for water source and wash block is depicted in Figs. 7 and 8 respectively. Fig. 7 depicts the equity in distribution of water sources. Among the total installed water points, the highest number was installed in Rajshahi division followed by Chattogram and Sylhet division while the minimum number of water points was installed in Mymensingh division. This is as per need assessment criteria and approved list issued by DPE based on approved IPG.

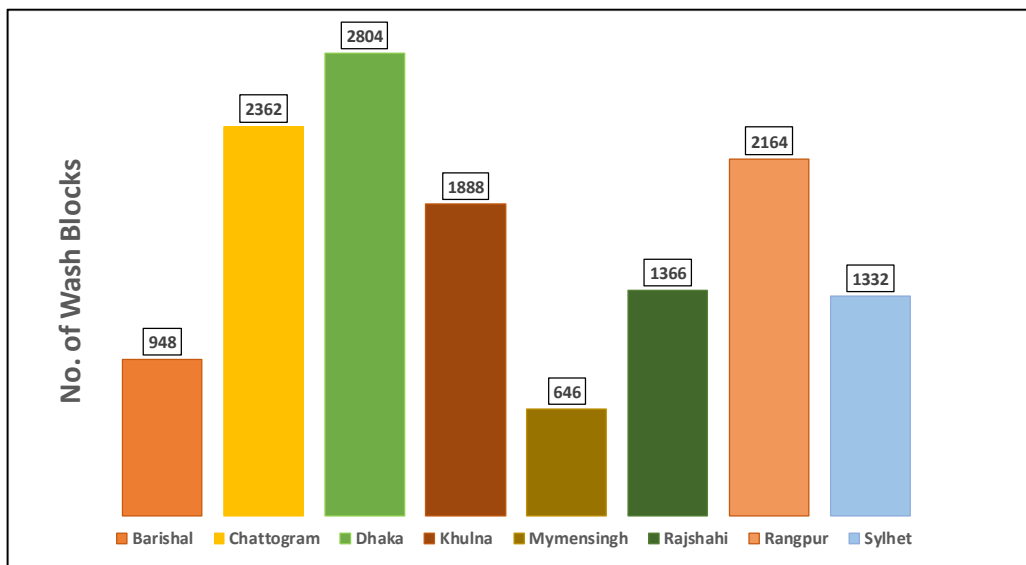
Fig. 8 Countrywide distribution of wash blocks

Fig. 8 reflects the countrywide distribution of wash blocks depending on the number of districts and upazillas in each division. The maximum number of wash blocks were constructed in the Dhaka, Chattogram, Rangpur, Khulna division as these divisions cover maximum districts. The lowest number of wash blocks (646) was constructed in Mymensingh division as it is the smallest division of Bangladesh and thus, equity in distribution is justified.

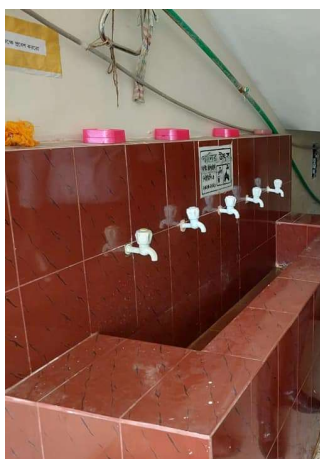
Fig. 9 water collection basin of 5 outlet

- 1) Pipe out used water to the existing drains.
- 2) Construction of 5 user water collection basin having 50mm dia. PVC washout pipe. Fig. 9. Shows a newly constructed 5 outlet hand washing basins under PEDP-4.
- 3) Use of 5 ring soaks well to drain out basin water where surface drain is absent.

As because, DPHE local office took initiative in solving the drainage issue, it has been observed that, the water logging problem is insignificant compared to that in PEDP-3. However, it is revealed that out of 1,668 water sources about 0.48% had the problem of water logging. The reasons observed are mainly lack of cleanliness which created blockage of drainage pipe by wastes like paper, tree leaves, mud etc. It is hence suggested that, SMC needs to look after this issue and run regular cleanliness program in the water collection basin and drains.

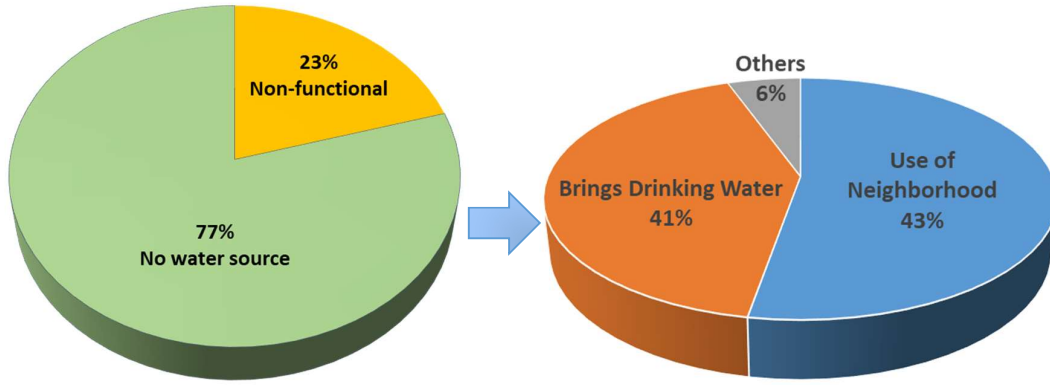
Fig. 10 Assessment of schools where new water points were installed

During preliminary survey it was found that, out of 1,668 schools 77% did not have their own active water option. 43% of them used the facility of their neighborhood. Though 23% schools have their own tube wells, yet those tube wells were found as non-functional or did not provide sufficient water during dry season. From the lessons learnt during the environmental screening in PEDP-3, DPHE took initiative in solving the above problem by installing new tube wells with submersible pump but at different depth as appropriate to the site geology.

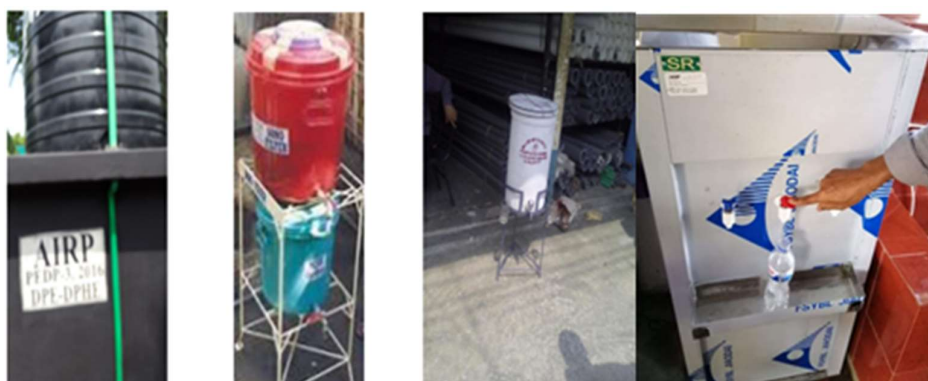
Fig. 12 Different Suggested Improved Filtration Technologies

below the BDS standard of drinking water. Fig. 12 shows some of the suggested filtration technologies.

It is fact that, in the reporting tenure a total of 39 water sources were found to have water quality concerns with excessive iron, chloride or arsenic. For all the said 39 water points, options like Reverse Osmosis (RO) were installed and filtered water was tested in DPHE zonal Laboratories. The water sources were handed over to the respective schools once the water quality results were found satisfactory. Water quality test results are summarized in Table 2 of Appendix 7.

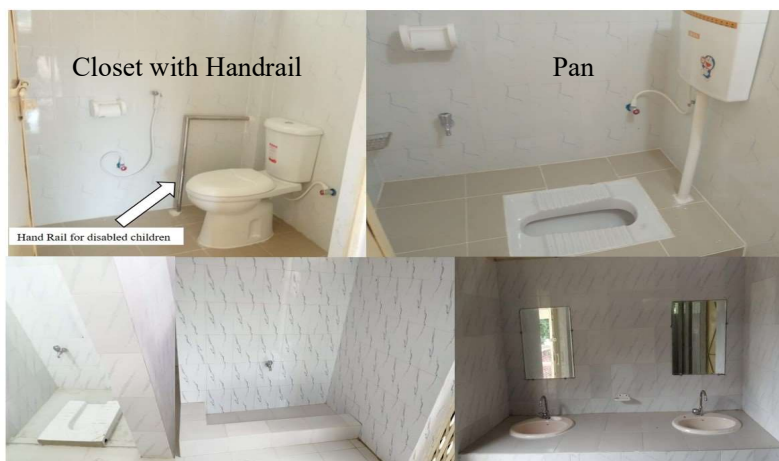
Fig. 13 Modern Interior of Wash Blocks

Prior to the installation of water sources, hand washing of students before and after meal especially mid-day meal and after using toilet was a matter of concern. As a result, students were more susceptible to diseases which triggered the absence of students from school. Besides these, newly constructed wash blocks with modern interior facility will surely create enthusiasm among children for the best utilization of wash blocks. A glimpse of wash block interior is shown in Fig 13.

Working with the motto of 'clean hand, safe hand' DPHE confirmed the installation of tube wells with running water supply by provision of submersible pump in all the above-mentioned schools during the reporting tenure. Construction of wash basin for hand washing (Fig.9) ensured total hand washing facilities in the school. Due to the global pandemic situation, although regular hygiene promotion activities could not be conducted yet monthly coordination meeting with DPE officials, TEO, ATEO and Primary School Headmasters is the indication of intensity of preparation for hygiene activities.

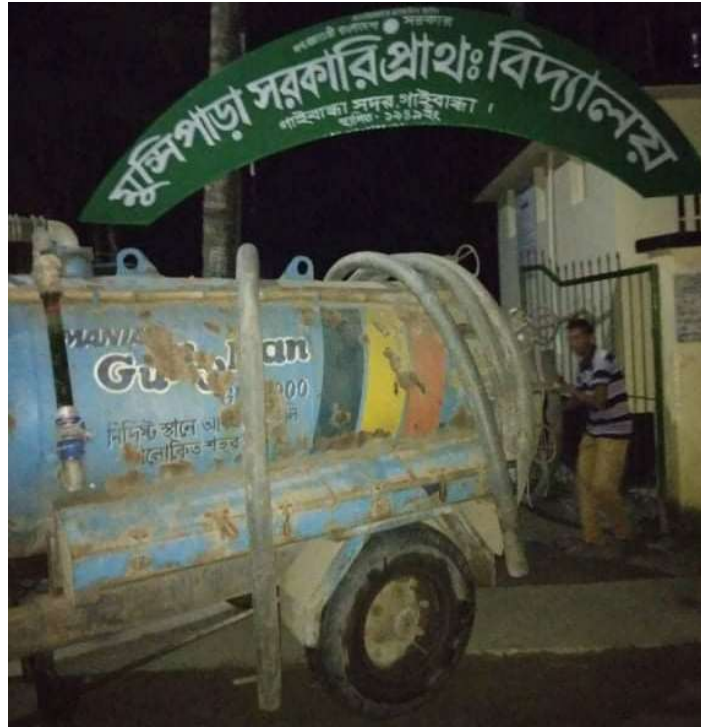
(a) Cleaning preparation of septic tank by using vaccu-truck at Gaibandha

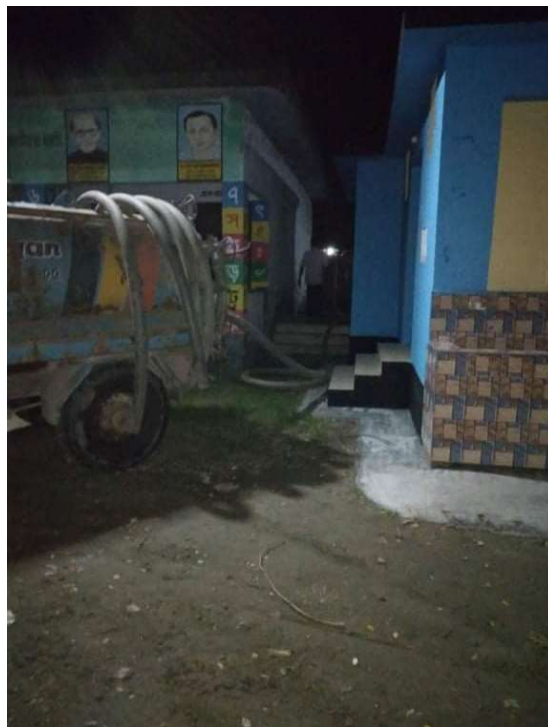
(b) Cleaning of septic tank by using automatic vaccu-truck at Gaibandha
