4th Primary Education Development Program (PEDP-4)

Semi-Annual Environmental Monitoring Report

DEPARTMENT OF PUBLIC HEALTH ENGINEERING

[A report on WASH facilities and its environmental impact under PEDP-4]

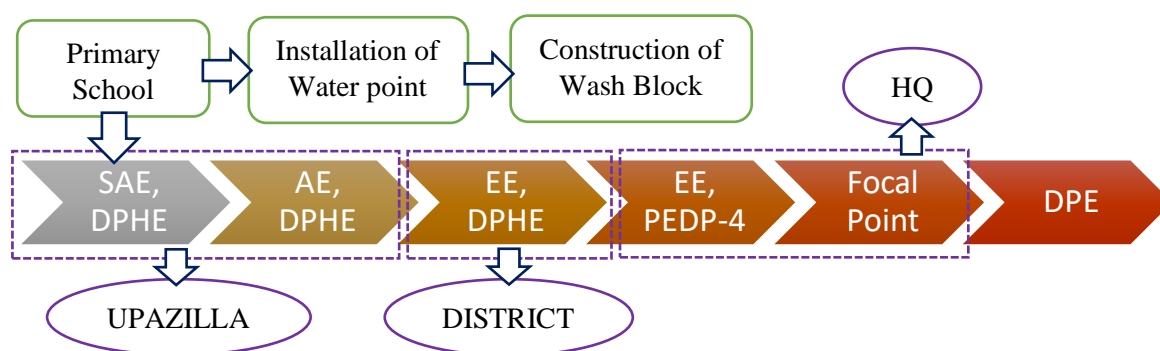
Fig. 1 Method of environmental safeguard screening

Data for environmental safeguard screening during the installation of water sources and maintenance of Wash Blocks have been collected from the schools through DPHE official sources using the structured format (copy enclosed in Appendix-1 of this report). Data collected from grass root level have been entered into 'Master Environmental Survey Outcome' Spreadsheet by MIS UNIT and kept structured for database and reporting. A flow diagram of the screening method is depicted in Fig. 1.

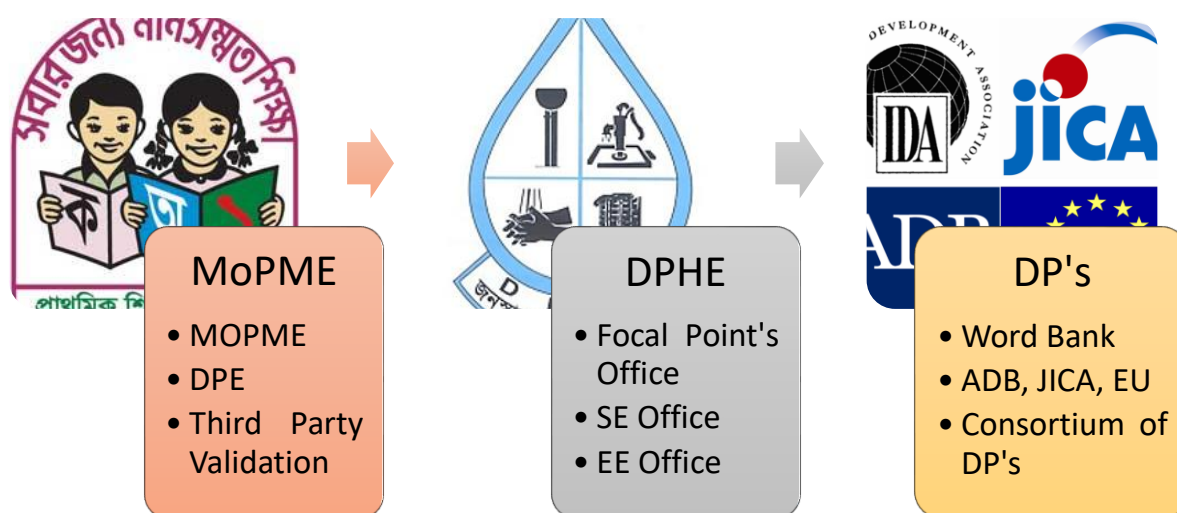
Fig. 2 Monitoring scheme in PEDP-4

The subcomponents of PEDP-4 especially the infrastructural implementation is comprehensively monitored by several parties from commencement to operational phase. Fig.2 shows the monitoring scheme in PEDP-4 operated by different agencies. Being an implementing agency, DPHE is involved significantly from construction till post-construction monitoring. Role of DPHE is depicted in Fig.3. It can be noted that the defect liability period for installed water points and constructed wash blocks are 02 and 01 year respectively. This implies that contractor is responsible to rectify any sort of defects within this time frame counting from the date of handover of tube well and wash block. In order get a clear picture of ongoing and completed works, DPHE district office arranges monthly monitoring meeting with all concerned officers and staffs of that district. Executive Engineers thus address the issues of monitoring to the assistant/ sub assistant engineers monthly. Officers of concerned district used to visit the site frequently in order to monitor the ongoing and completed works and also focus on

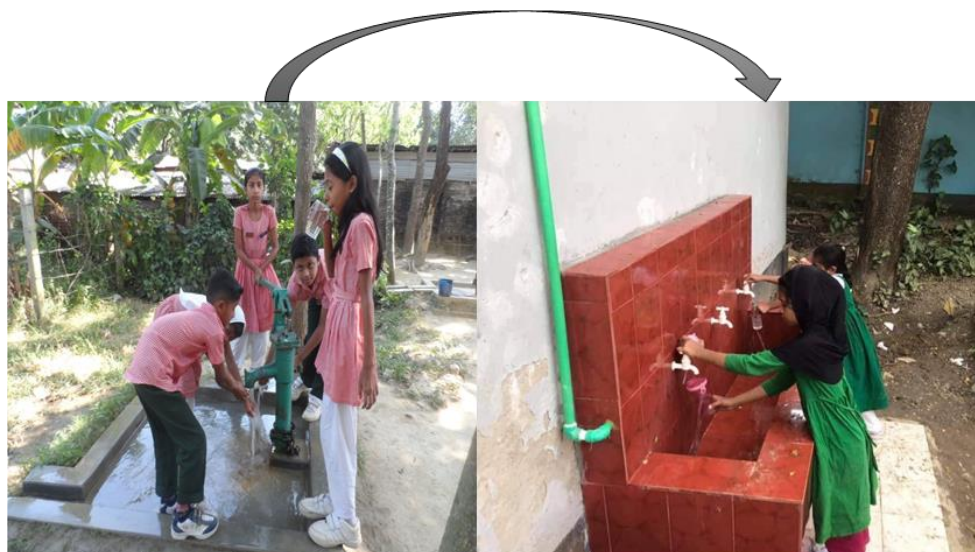
Fig. 6 Improved water sources by TSP from hand tube well

In order to mitigate the concerns and to make the water sources more popular and user friendly, DPHE started installing Tube well with Submersible Pump (TSP) in all the primary schools under PEDP-4. This option has special features such as-

- Running water supply with storage facility.
- Multiple user can access at the same time.
- Promote hygiene practice through safe hand washing.

Fig. 6 shows the previous and improved water supply facilities in primary schools under PEDP-4.

Installation of tube well with submersible pump added values to its user especially young user which eventually increases the easy access to safe drinking water result in health benefit as well as diminishes water logging and drainage problem.

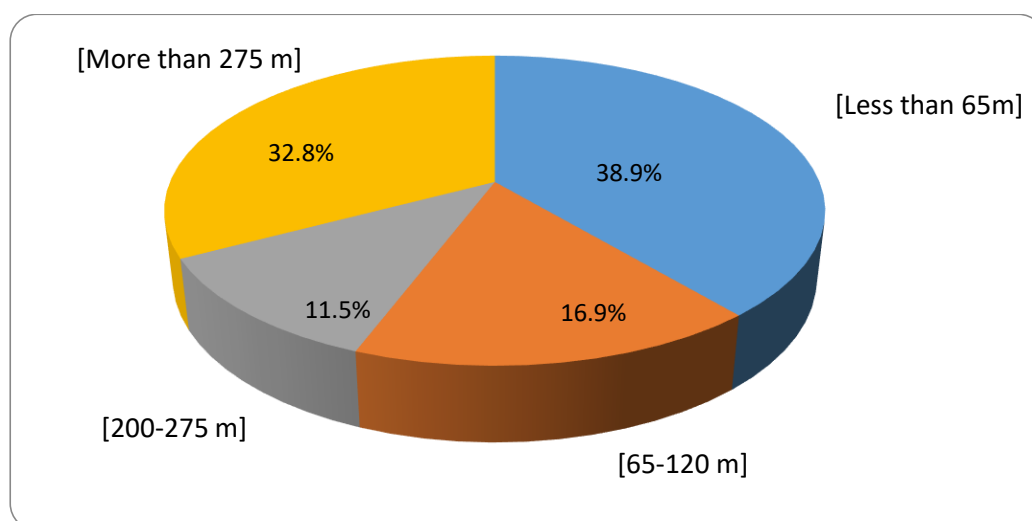
Fig. 7 Distribution of water points based on depth

DPHE installed tube wells of varying depth in different primary schools of Bangladesh considering the geological formation of respective district. Although the depth of tube well is depended on the suitable water layer, all the tube wells installed in the reporting tenure can be broadly categorized into four distinct types based on the depth of tube well. Fig. 7 depicts the classification of tube wells based on depth. It is clear that 44.3% tube wells were installed at a greater depth of more than 200m. Number of shallow tube wells were in the range of 38.9% where the depth is less or equal to 65m.

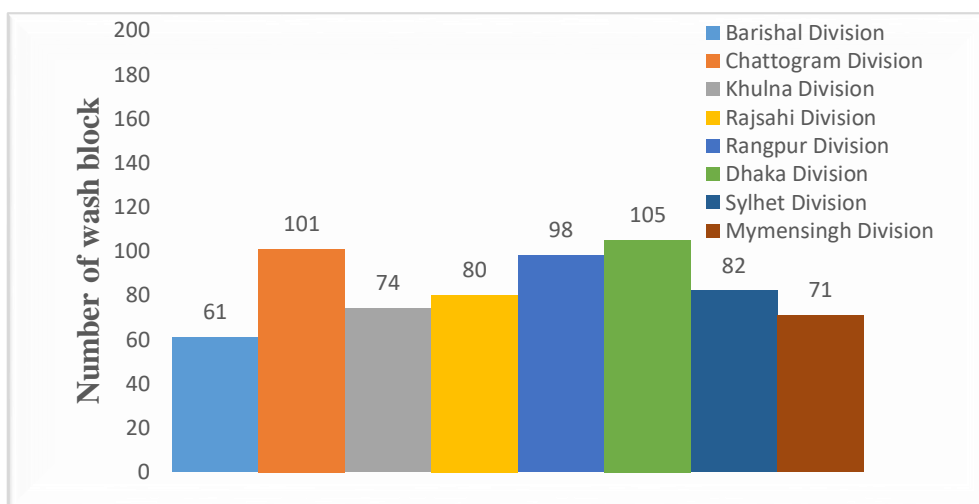
Fig. 8. Countrywide Wash Block distribution

Countrywide distribution of Wash Blocks and Tube wells were surveyed and categorized division wise. Fig. 8. reflects that the distribution of wash blocks follows uniform pattern and Fig. 9 also depicts the uniform distribution of water sources.

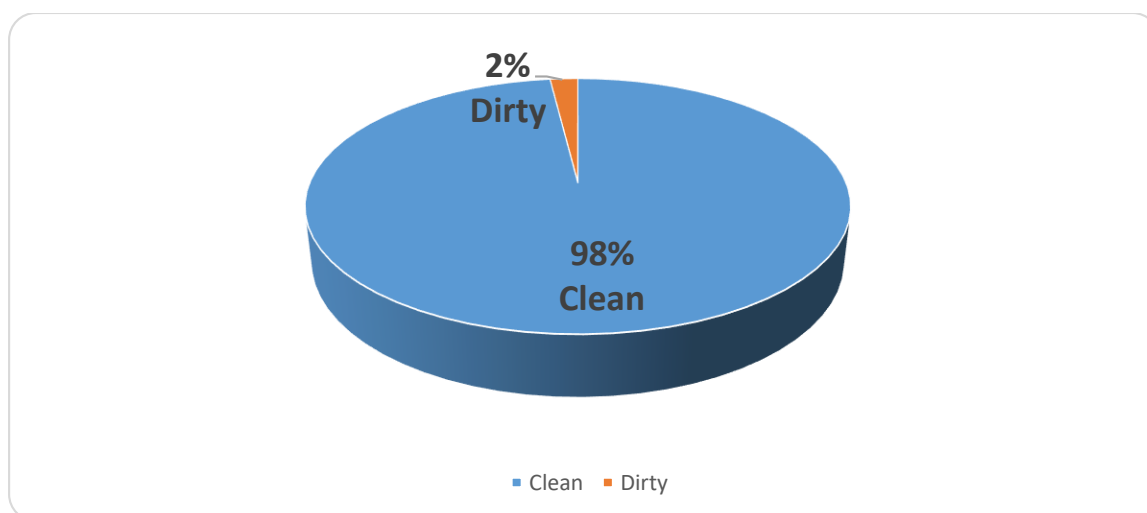
Fig. 10 Environment of water supply facility

In case of water points 'Clean Environment' refers to the surrounding of the installed water option. If the surrounding environment is not dirty and/or not covered with algae then it would be referred to as 'Clean'. Post installation monitoring of all 2145 water points have been conducted. Clean environment was found in 2103 water points which is 98.04% of the total water points as depicted in Fig. 10. As the schools were closed due to the COVID-19 situation, there was lack of maintenance and blocked drainage due to waste dumping near the outlet was observed. It can be noted that due to the provision of basin type water points, water logging and or other problems related to dirty environment have been dramatically reduced than that observed during the environmental screening of other types of tube well installed in PEDP-3 program.

During the monitoring phase, mitigation measures were suggested to the concerned school such as cleaning of basin, removal of leaves and other utensils that causes blockage of the drains etc. Because of taking mitigation measures, caretakers' training and routine maintenance during monitoring phase, environment of water supply facility improves to 100% from 98.04%.

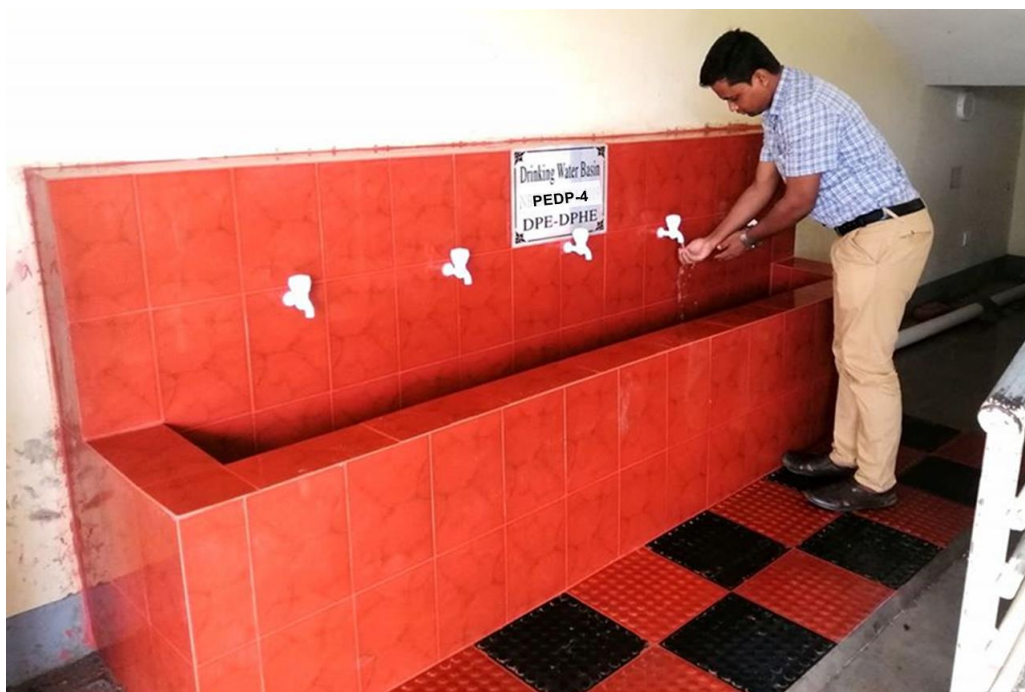
Fig. 11 Tube Well with Submersible Pump having 05 running water outlets

- 1) Pipe out used water to the existing drains.
- 2) Construction of 5 user water collection basin having 50mm dia. PVC washout pipe. Fig. 11. shows a newly constructed 5 outlet hand washing basin under PEDP-4.
- 3) Use of 8 ring soaks well to drain out basin water where surface drain is absent.

As because, DPHE local office took initiative in solving the drainage issue, it has been observed that, the water logging problem is insignificant compared to that in PEDP-3. However, it is revealed that out of 2145 water sources less than 1% had the problem of water logging. The reasons observed are mainly because of current COVID-19 situation schools are closed and hence the lack of cleanliness program was observed which created blockage of drainage pipe by wastes like paper, tree leaves, mud

etc. It is hence suggested that, SMC needs to look after this issue and run regular cleanliness program in the water collection basin and drains.

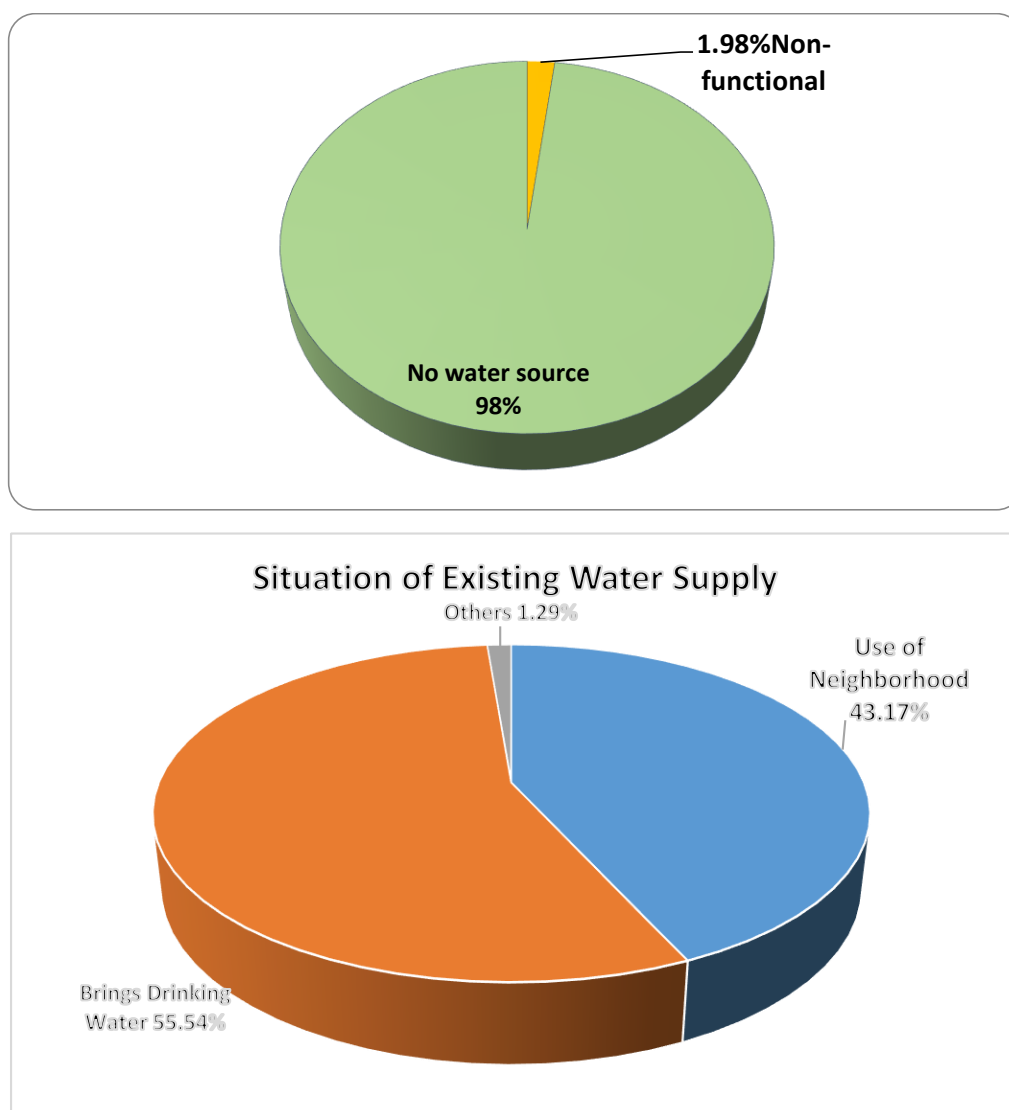
Fig. 12 Assessment of schools where new water points were installed

During preliminary survey it was found that (Fig.12), out of 2145 schools 98.02% did not have their own water option. 43.17% of them used the facility of their neighborhood. Though 1.98% schools have their own tube wells, yet those tube wells were found as non-functional or did not provide sufficient water during dry season. From the lessons learnt during the environmental screening in PEDP-3, DPHE took initiative in solving the above problem by installing new tube wells with submersible pump but at different depth as appropriate to the site geology.

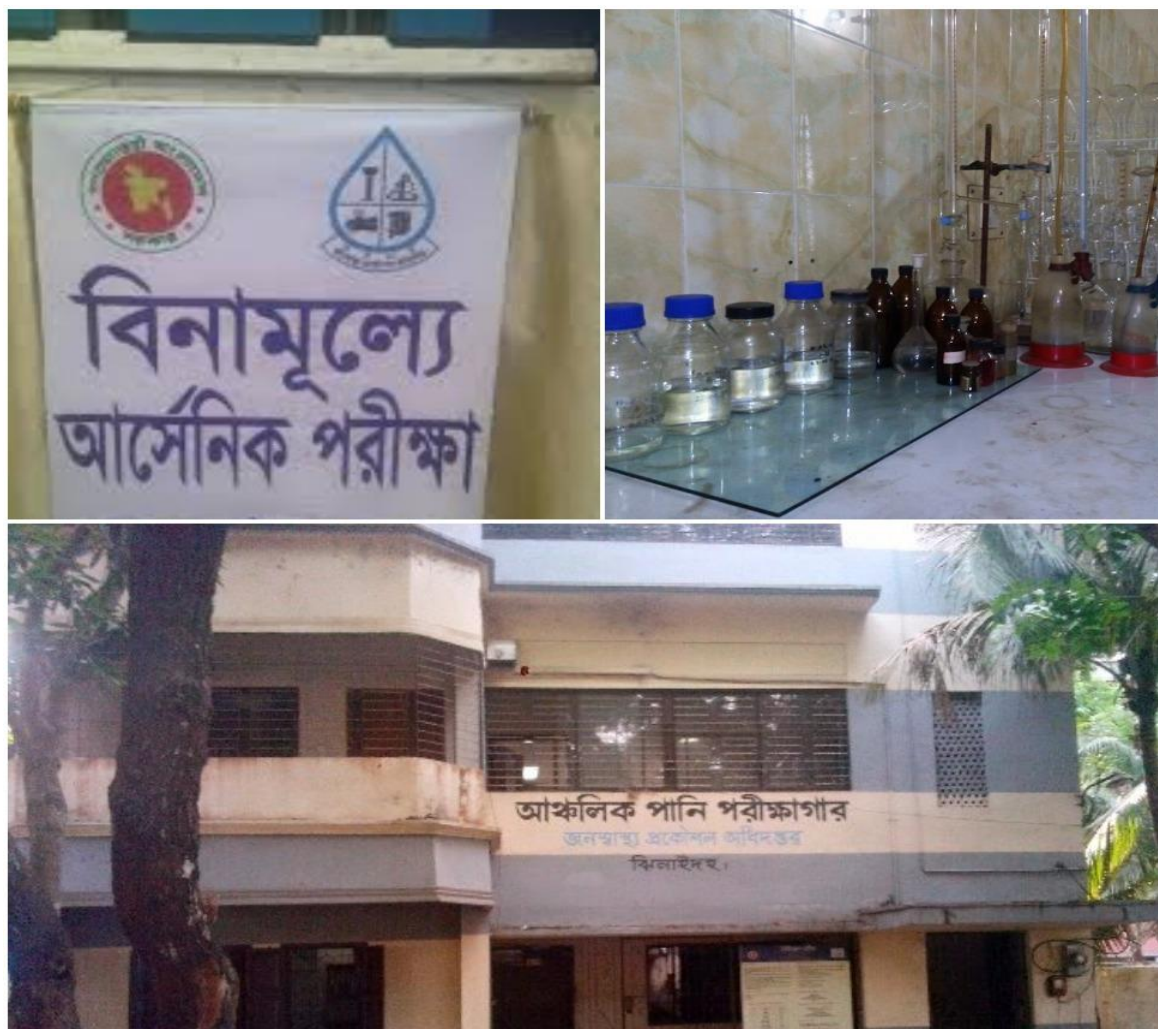
Fig. 13 DPHE Zonal Laboratory setup for water testing

During installation of water points, suitable water layers are generally selected based on the geographic location and DPHE's experience. After installation of new water points in the said 2145 schools, laboratory tests were conducted to identify potential hazards of Arsenic, Iron and Chloride in water. The tests were done by the laboratory circle of DPHE and the reports are stored in the DPHE MIS database. Figure below shows laboratory testing facilities of DPHE.

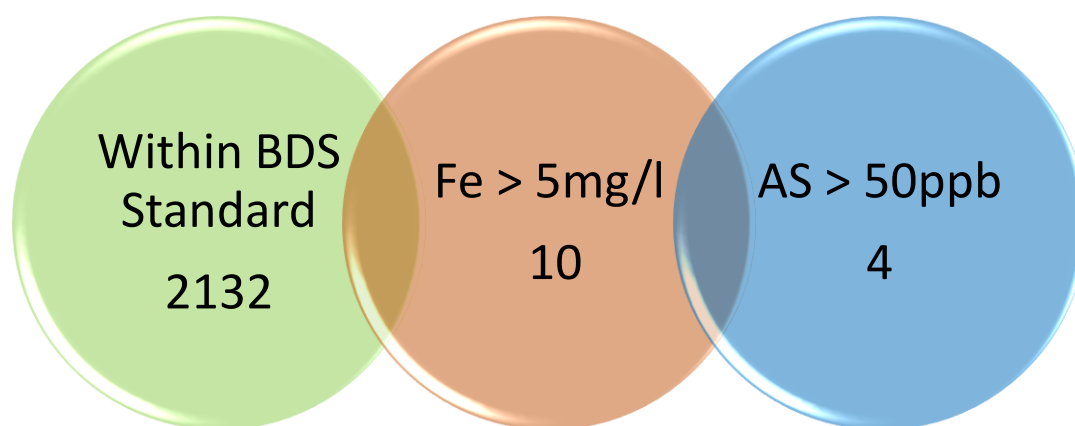
Fig. 14 Water Quality at a glance

From the screening of 2145 tube wells it was found that 13 of them had the concern of excess arsenic (As) and/or, Iron (Fe) beyond the Bangladesh standard (arsenic, iron and chloride content below 50ppb, 5mg/l and 600mg/l respectively) of safe drinking water. For the rest of the cases arsenic, iron and chloride content were found satisfactory during laboratory tests. Water Quality report of those 13 unacceptable water sources and suggested alternative option is summarized in Table 2. Fig. 14 shows the diagrammatic presentation of water quality test results. In addition, ample field tests were conducted in those schools during post monitoring phase by DPHE by using field kit which re-confirmed the

In cases where arsenic/iron/chloride is found beyond allowable limit in installed water source, DPHE adopts other approved alternate water options. DPHE goes for options like deep tube well of greater depth, ring well, pond sand filter, rain water harvesting, Reverse Osmosis Filter, AIRP etc. whichever is feasible. In some cases, if all the options in hand fails, i.e., boring in greater depth becomes impossible, arsenic is found even in deep tube well and none other option is feasible, DPHE has started implementing 'SONO Filter' as well. DPHE zonal offices arrange and install the said filter in those water sources and water from those sources is further re-tested. So, for those 13 water points different alternatives are being studied and the most feasible option will be implemented.

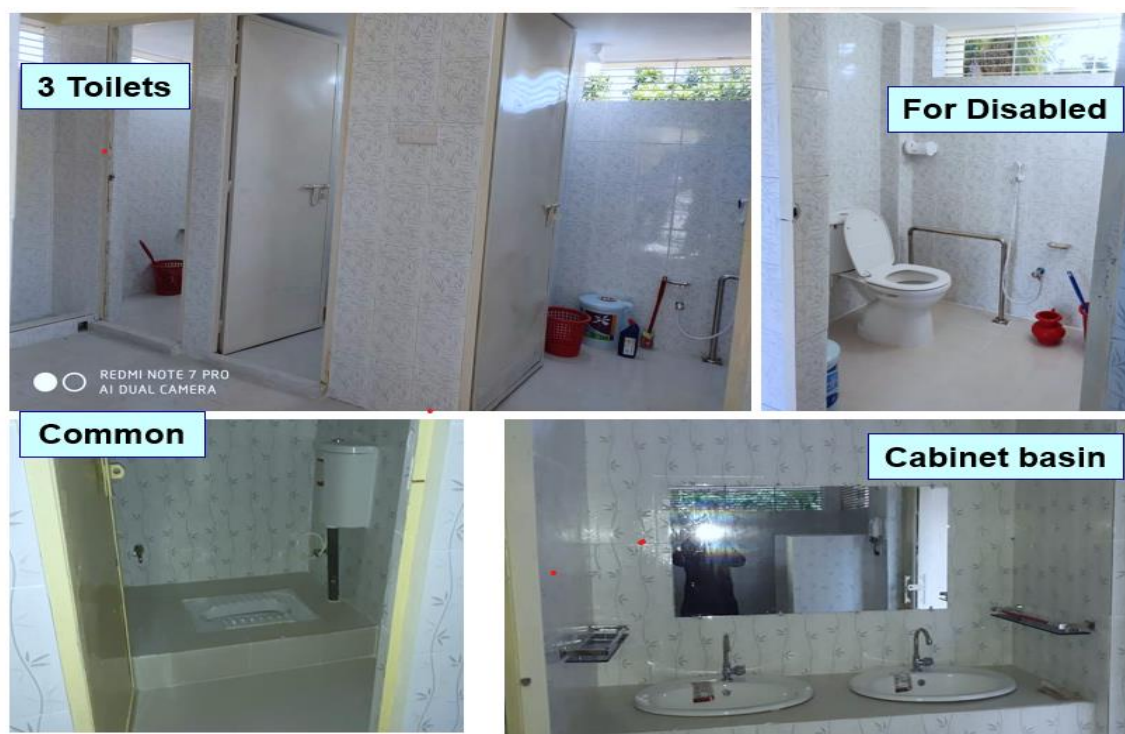
Fig. 16 Modern Interior of Wash Blocks

Prior to the installation of water sources, hand washing of students before and after meal especially mid-day meal and after using toilet was a matter of concern. As a result, students were more susceptible to diseases which triggered the absence of students from school. Besides these, newly constructed wash blocks with modern interior facility will surely create enthusiasm among children for the best utilization of wash blocks. A glimpse of wash block interior is shown in Fig 16.

Working with the moto of 'clean hand, safe hand' DPHE confirmed the installation of tube wells with running water supply by provision of submersible pump in all the above mentioned schools during the reporting tenure. Construction of wash basin for drinking as well as hand washing (Fig.13 as shown above) ensured total hand washing facilities in the school. Due to the global pandemic situation, although regular hygiene promotion activities could not be conducted yet monthly coordination meeting with DPE officials, TEO, ATEO and Primary School Headmasters is the indication of intensity of preparation for hygiene activities.

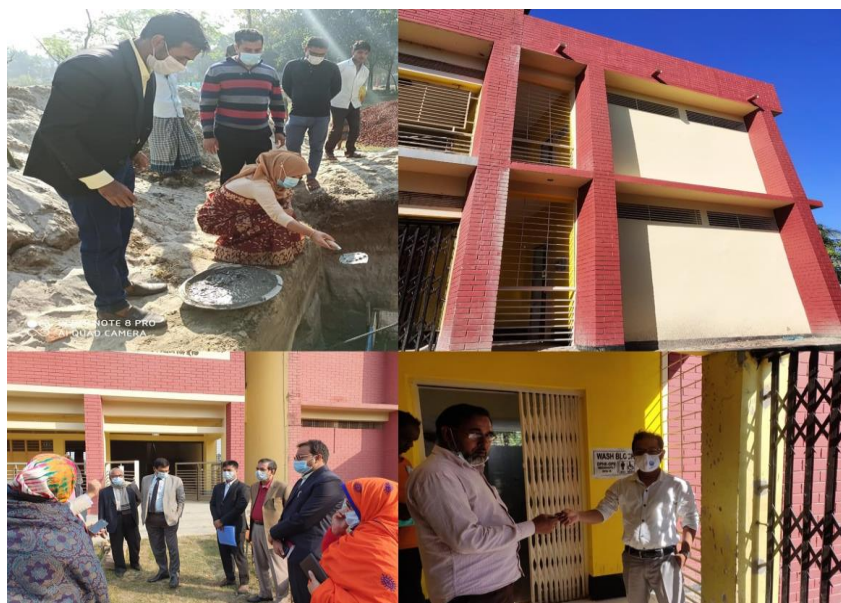
Fig. 18 Inspection of Wash block in presence of school authority

The post monitoring visit by SAE shows that the school is following the maintenance scheme properly.

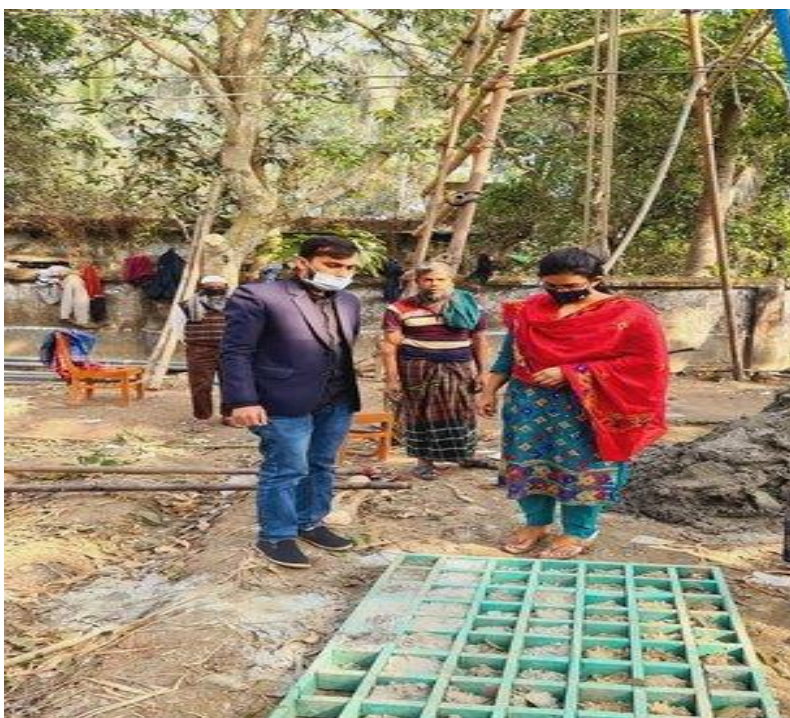
Fig. 19 Monitoring of Tube well installation in presence of Executive engineer, DPHE

During post evaluation phase in the findings were found satisfactory and the water source was found functional.
